HASTINGS OUTFALL PIPE INSPECTION

PREPARED FOR HASTINGS DISTRICT COUNCIL

20/09/2019

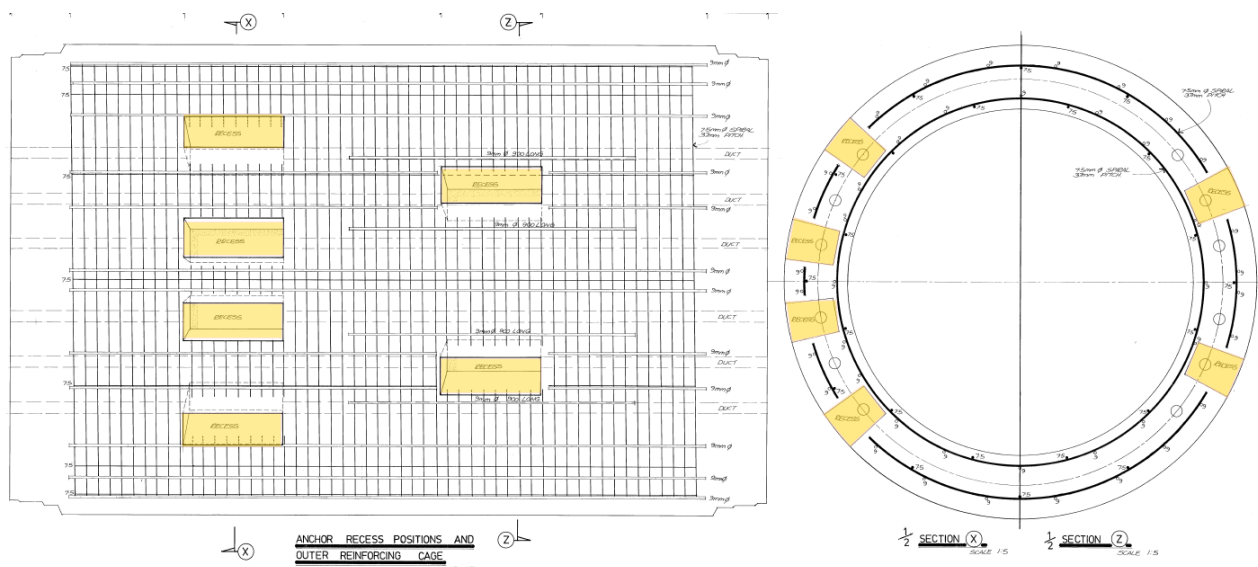
Figure 4-2: Anchor Pipe Detail

Similar to 4.3.3 for the reinforcing wires, should the high tensile steel anchoring and coupling blocks fail, there could be some recoil in the lines damaging the concrete and possibly compromising the axial strength of the pipeline. This could lead to further corrosion and joints opening. The status of the anchor plate within the recesses, highlighted in Figure 4-2, can be inspected by a diver externally.

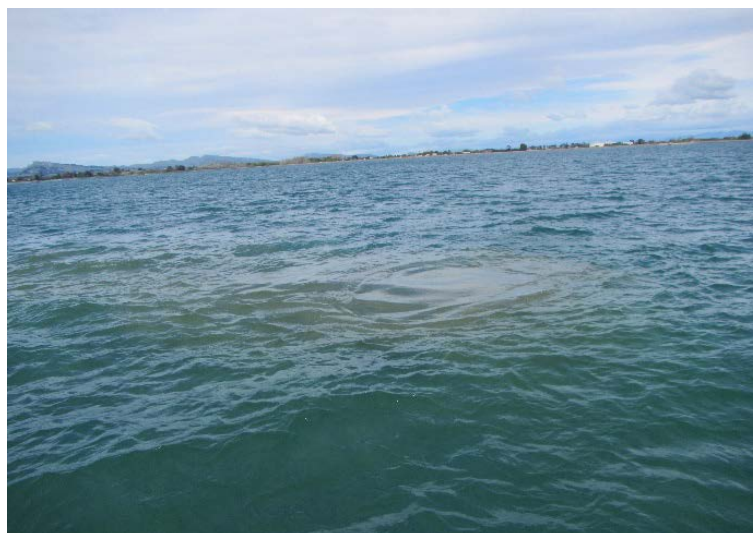
Figure 4-4: Plume on surface from damage to outfall

This pipeline has experienced damage to three joints from what was suspected to be a trawler, with complete failure of one joint that caused a visible discharge plume approximately half-way along the outfall. Repairs were carried out in 2016 to seal the pipeline with stainless steel bands at each of the three damaged joints.

Should a joint open due to one of the mechanisms outlined in Table 1, effluent would leak from the pipeline causing a plume as seen in Figure 4-4. This would likely occur as the pipe flexes due to subsidence or movement from wave loading. The pipe should be held in place by the surrounding soil where buried and bending would not be expected. The pressure in the pipeline may cause the joints to open up slightly should the prestressed reinforcing fail, however, as stated in Section 4.3.5 there may be some redundancy in the wires.

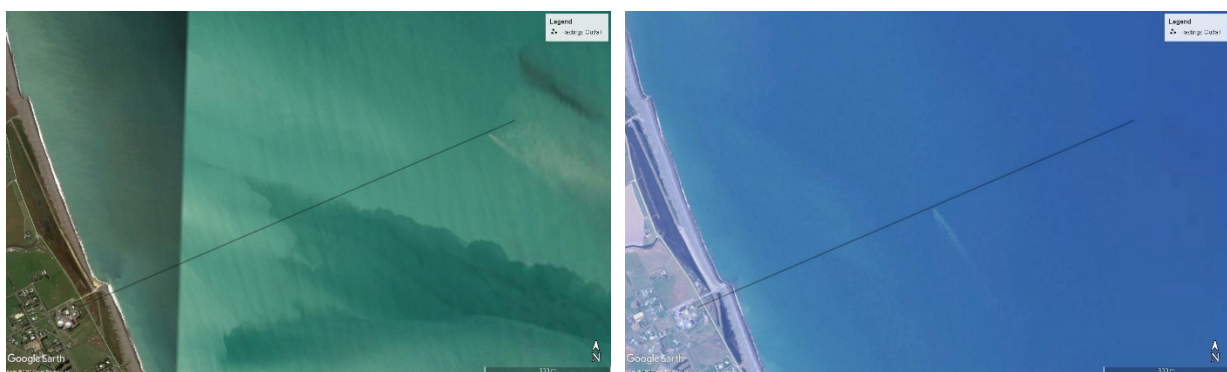
Figure 6-2: Satellite image of outfall with 2019 end plume (left) & 2015 mid break plume (right) (Maxar Technologies, 2019)

The plume from the outfall is visible in satellite imagery, see Figure 6-2. A commercial satellite imagery supplier may be able to provide periodical views of the outfall, which can be used to monitor if there is a break in the pipe and a plume appears along the length of the outfall, seen on the right below. Initial discussions with a local provider, Critchlow Ltd. indicated that the satellite image for the area is available on average once a month.

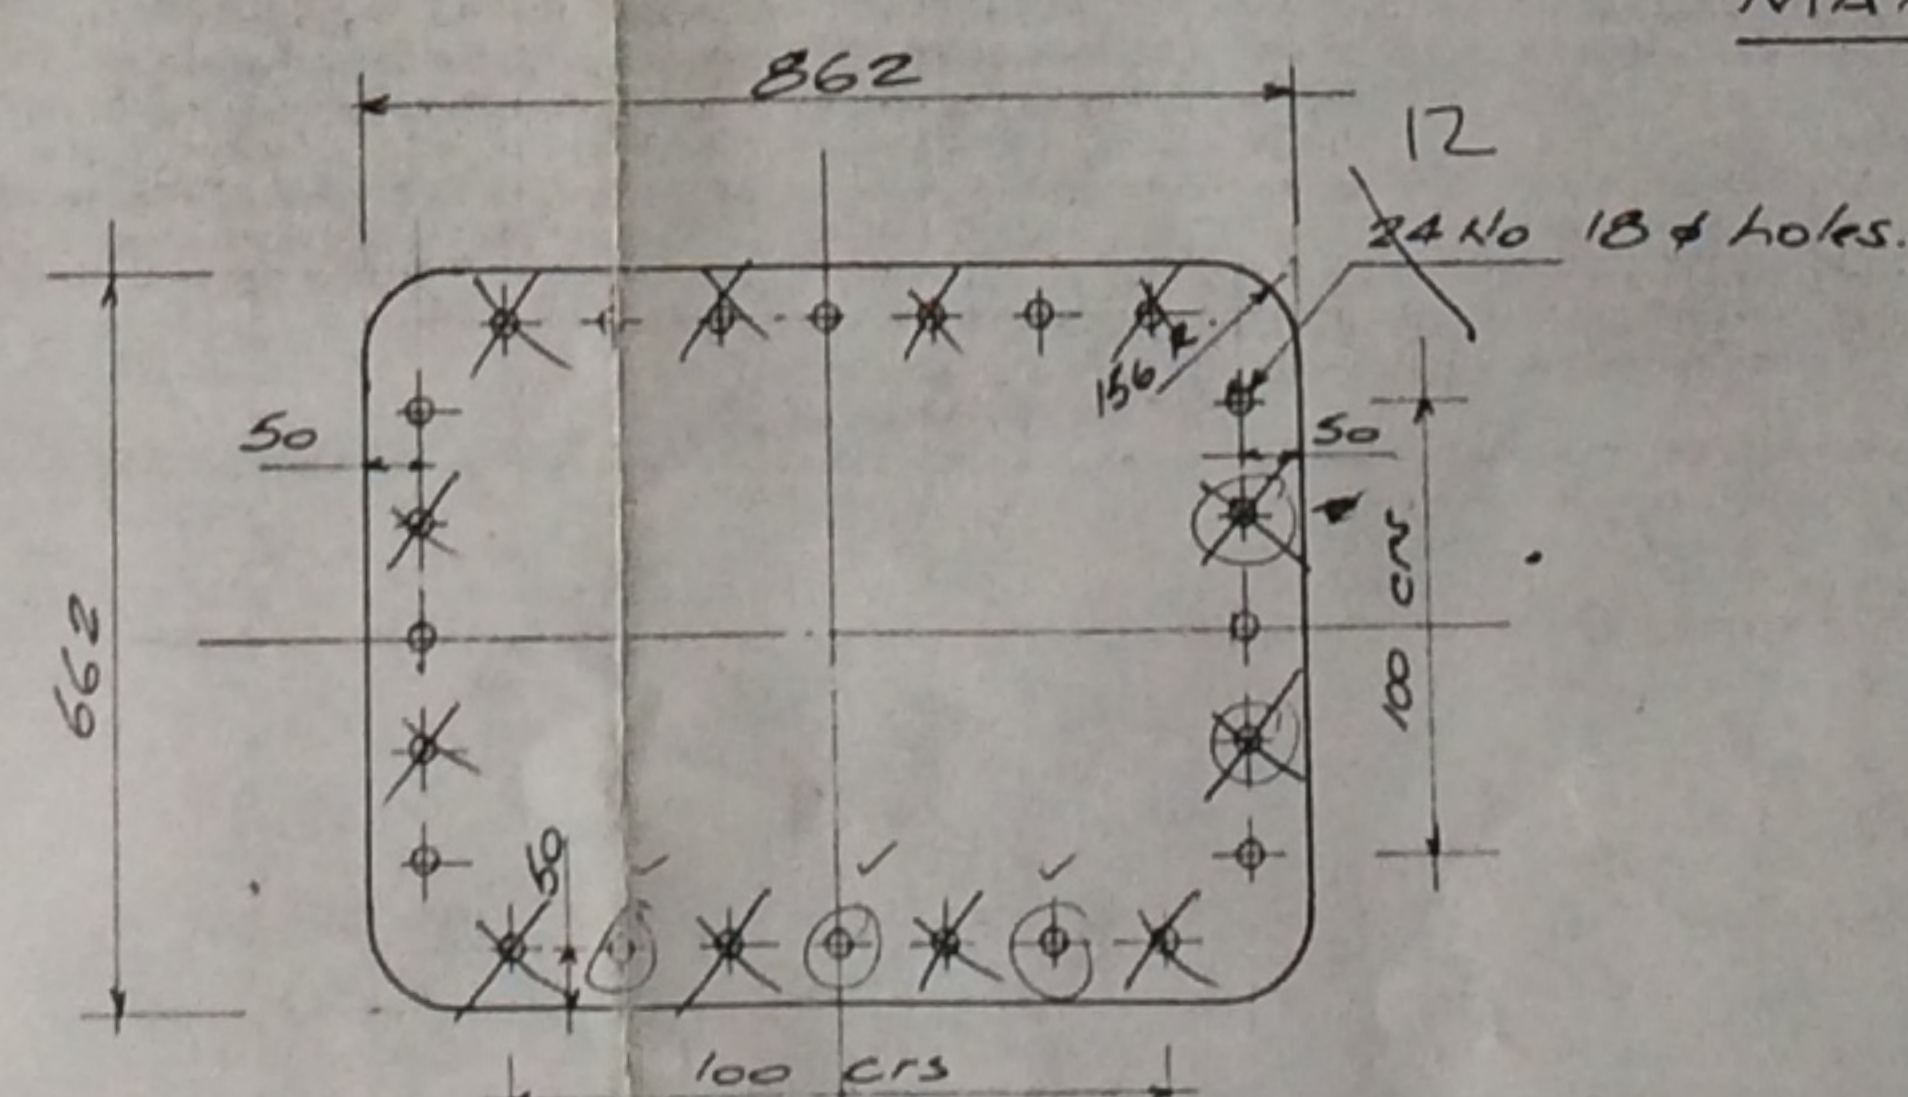
MANHOLE LID - 4 OFF.
EX 25¢.

Manhole access points are noted on the As-Built drawings on each of the nose pipes for most of the pipe strings at the underwater joints. These access points are recessed into the nose pipe, shown as a 25mm thick top plate which is 662mm by 862mm and fixed with 12 bolts. Clear opening through the pipe is 450mm by 650mm.

The drawings do not indicate any corrosion protection to the steel access points. It is likely that these would have significant corrosion and could be a point of future failure. They may also be of use for access for inspection or condition assessment.

It is recommended that a dive inspection to these points is carried out to:

- Check on condition and identify repair works required for access.
- Use as a reference to confirm the top of the pipeline so concrete pipe core samples can be taken with confidence away from the side tensioning strands.
