Repair Report on the leak on the Hastings WWTP Main Outfall Pipeline

Prepared for: **HASTINGS DISTRICT COUNCIL**

July 28, 2017

Project No.: 80501215.0206

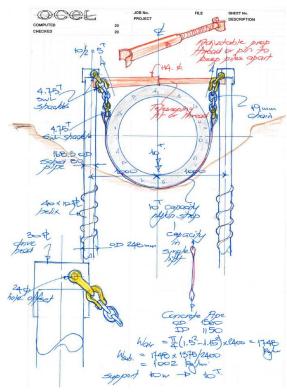
When carrying out the above repair the divers discovered steel supports beneath the pipe. The diver's halted works in case the steel supports were providing structural support from some earlier works. A temporary band was installed to stem the discharge from the joint. This is shown in the conceptual sketch below.

Figure 1 OCEL prepared concept sketch to repair joint leak

- Investigation dive
- Air scour to expose pipe joint
- Remove old pipe joint band
- Replace with new stainless steel band

The installation of some support piles and strops for vertical support with the pipe excavated beneath were carried out with the intention to continue to have the outfall functioning.

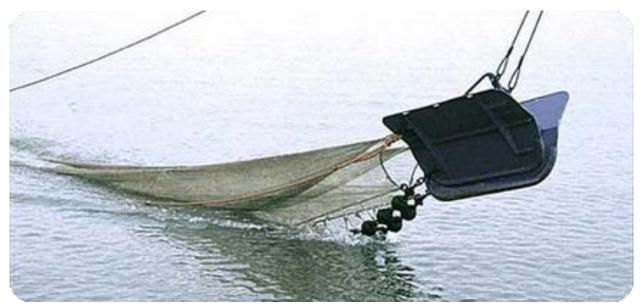
From the damage observed by the divers during inspections, there is a high probability that the damage was caused by the pipe joint being struck by an object. This may have been caused by trawler boards (or otter boards) that act as a plough anchor to keep the nets close to the seabed.

Figure 2 Picture of trawler board

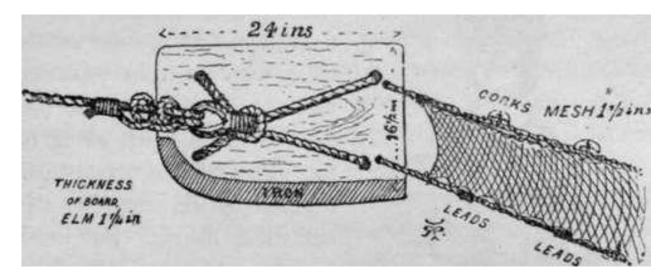
Figure 3 Diagram of trawler board
