NAPIER OCEAN OUTFALL INSPECTION

REPORT NUMBER: NOOIO1 010220

NAPIER CITY COUNCIL

25 JANUARY TO 1 FEBRUARY 2020

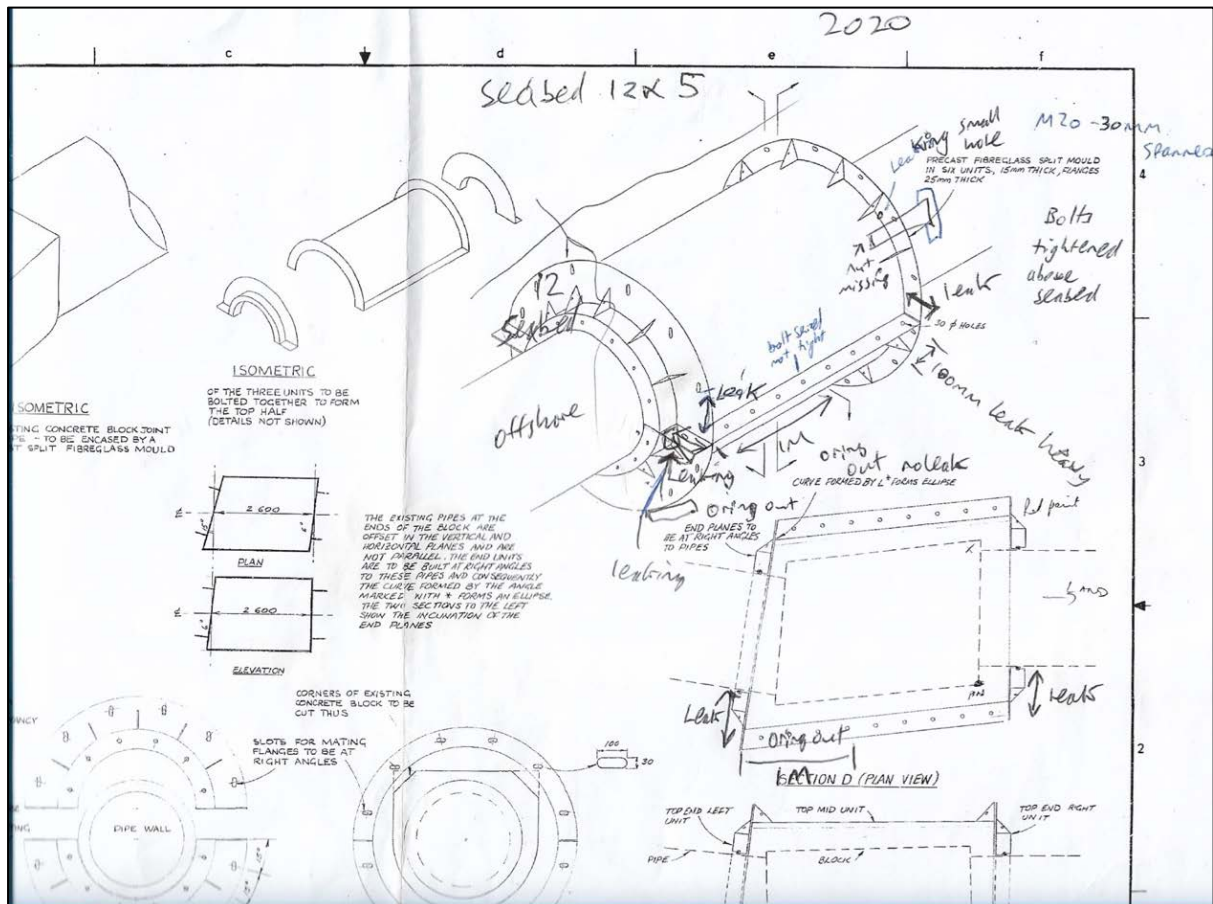
Image 1: Marked Up Drawing of the Findings

The leaking joint at 700m was located. Seabed levels were at the 11 o'clock to the 4 o'clock looking onshore. An inspection was conducted in consultation with Ian Goss (Consultant Beca). The leak was similar to the last inspection. The flow rate during the inspection was

approximately 425L per second. Leaking around the onshore and offshore flanges was prominent, as shown on the below drawing. The southern side of the joining flange (along the 9 o'clock) side was buried and not inspected. The northern joining flange was observed to be leaking some sections and the rubber seal appeared to be missing from the sealing faces.

All bolts on flanges that were accessible were tightened. The offshore flange bolts were all loose.

- a. Fabricate new diffusers and replace the damaged ones
- b. Installation of diffuser in the open hole
- c. Clean mussel growth from the diffusers
- d. Installation of new duckbills on diffusers
- e. Repair leak at 700m
- f. Installation of clamp around broken join close to end of pipe
- g. Blank buried diffusers or installation of risers
- h. Re-drill and installation of studs in hockey stick flange
- i. Clear sediment out of pipe from onshore to offshore

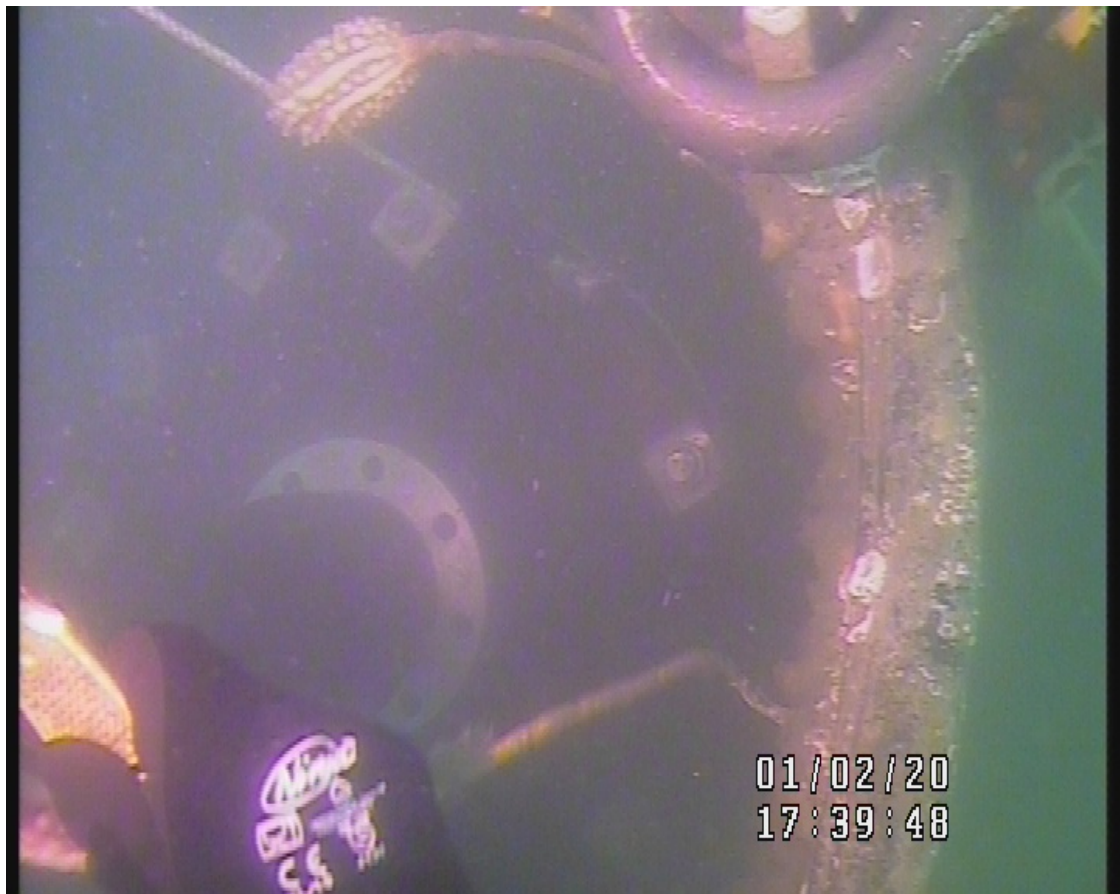
Image 2: Top of the Hockey Stick in Relation to the Top of the Caisson

The caisson was uncovered and airlifted out. The sediment inside appeared to be compact with sticks which proved difficult to clear. The end of the pipeline was uncovered and air lancing of sediment from inside of the pipe was conducted.

The hockey stick was installed onto the end of the pipe using studs previously ChemSet into the pipe. This was challenging as the caisson was on a lean to the north east as the caisson interfered with the alignment process. The HDPE stub flange was made with a very tight tolerance which made it difficult to fit inside the installed studs. The studs themselves were not all exactly straight and some studs were required to be removed to allow some of the studs to fit. Five (5) bolts were successfully installed however unable to fully secure the stub flange to the concrete. There was a gap approximately 150mm at the bottom. Two (2) holes will need to be re-drilled at the bottom of the flange to enable this. The hockey stick top was secured to the caisson utilizing truck strops. The top of the hockey stick was approximately 500mm below the top of the caisson. An anode was installed at the 12 o'clock stud on the galvanised flange. A duckbill arrangement will need to be installed to the top of the hockey stick.
