NAPIER CITY COUNCIL

**NAPIER OUTFALL AND DIFFUSER INSPECTION REPORT 2016
INCORPORATING FOLLOW UP INSPECTION**

December 2016

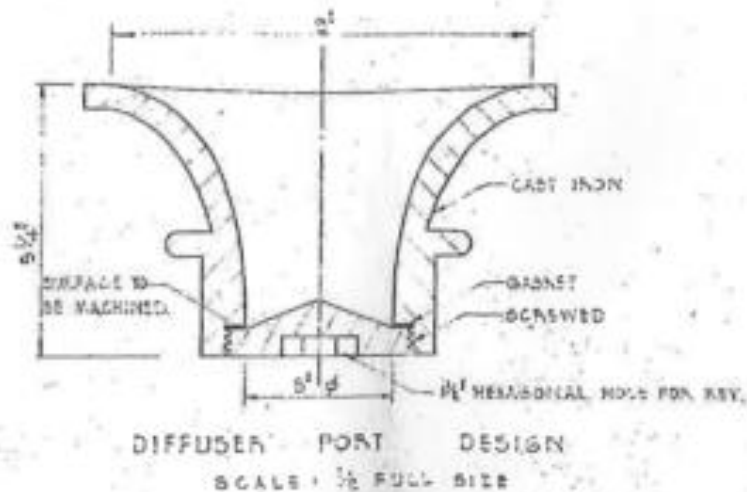
Figure No 1. Diffuser port detail from Drawing S322/4

The diffuser section forms the end 120 m length of the outfall. The diffuser ports are located on top of the diffuser but the information supplied to OCEL was limited in detail and did not clearly specify the port/duckbill detail, total number of ports or the pipe connection detail. Drawing No S322/4 shows a cast iron diffuser port unit that is cast into the concrete outfall pipe - Figure No 1. How the existing risers are connected to this detail is not clear. The existing vertical risers inspected on the diffuser consisted of a tube welded to a square plate secured to the diffuser plate by 4 bolts. A duckbill was attached to the top of the riser. In some cases the top of the duckbill was either flush with or just below the seabed. Some of the risers were loose.
