NAPIER OUTFALL LEAK AND DIFFUSER INSPECTION AND REPAIRS

REPORT NUMBER: NOLD01 050520

NAPIER CITY COUNCIL

30 APRIL – 5 MAY 2020

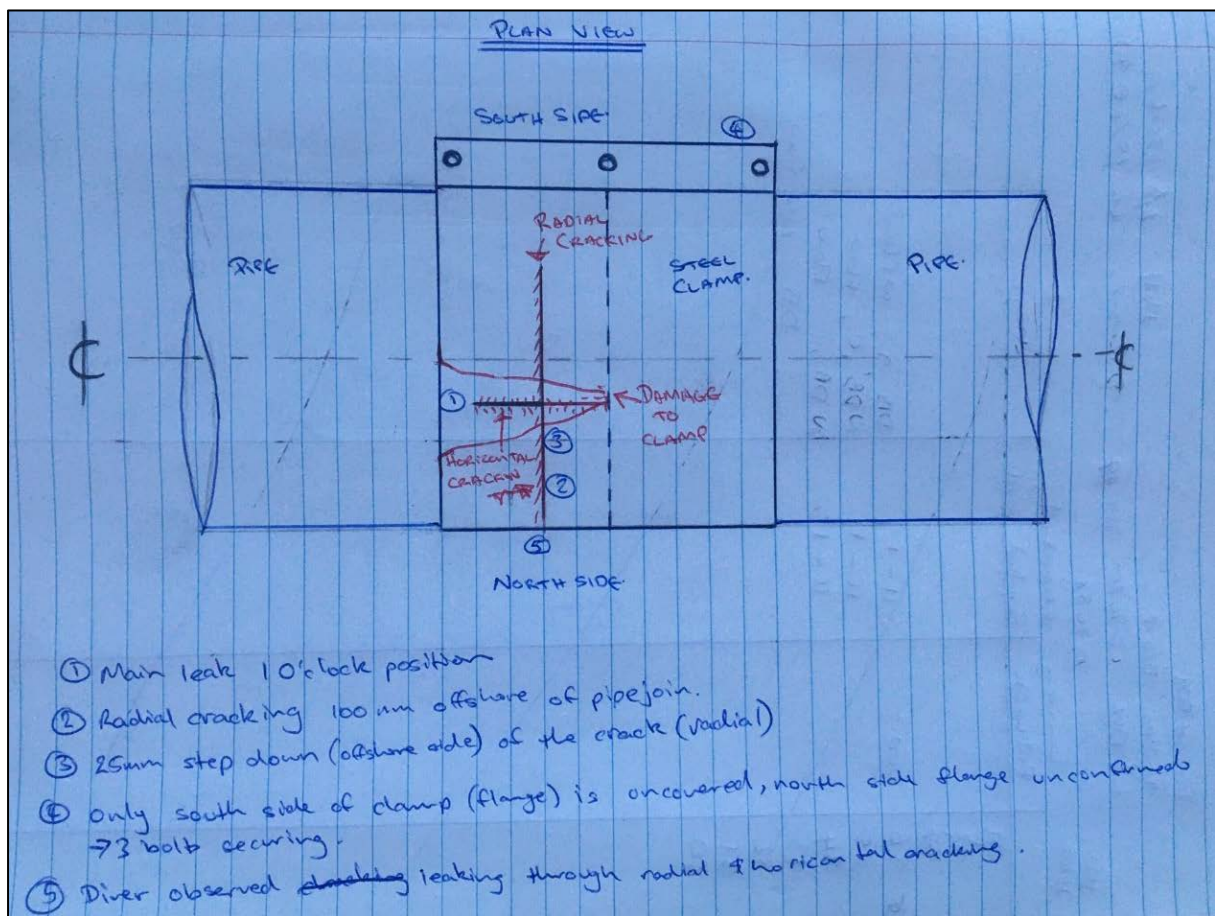
Image 2: Plan View

A leak was located approximately 60m inshore of the fibreglass clamp site (CH750). The pipe was observed to be buried between approximately 300 – 700mm below the seabed.

An airlift was utilised to excavate the leaking area. The leak appeared to be an old clamp repair site that had deteriorated. The clamp was found to be a steel band type and bolted on one side. The band was approximately 500mm wide and was positioned around a pipe join. The offshore edge of the band appeared to be damaged with the offshore edge of the band lifted away from the pipe with a tear approximately 250mm long. This exposed a horizontal crack in the concrete pipe which was approximately 200mm long propagating from the pipe join on the offshore pipe. A radial crack was observed under the clamp which was approximately 100mm offshore of the join. Access was limited under the steel band however the leaking was felt around to approximately the 3 o'clock position on the northern side and to at least the 10 o'clock position of the southern side. The offshore side of the radial cracking was approximately 25mm lower than the inshore side of the cracked pipe. The repair area was found to be supported by concrete blocks that appeared to be cement filled bags. The bags

appeared to have deteriorated and no fabric from these bags was observed to remain. These bags were observed under the pipe and stacked in a pyramid type formation to support the sides and protect the top of the pipe.

During this attendance the bags covering the top of the pipe and halfway down the sides were removed to gain access to inspect the old repair.

A temporary repair solution is still to be formulated and the leak area was left as is. Sketches of the findings are below.
