EXTRAORDINARY SUSTAINABLE NAPIER COMMITTEE

1. NAPIER AQUATIC CENTRE CAPITAL REVIEW PROGRAMME

<i>Type of Report:</i>	Operational and Procedural
<i>Legal Reference:</i>	N/A
<i>Document ID:</i>	1431044
<i>Reporting Officer/s & Unit:</i>	Glenn Lucas, Manager Sport & Recreation

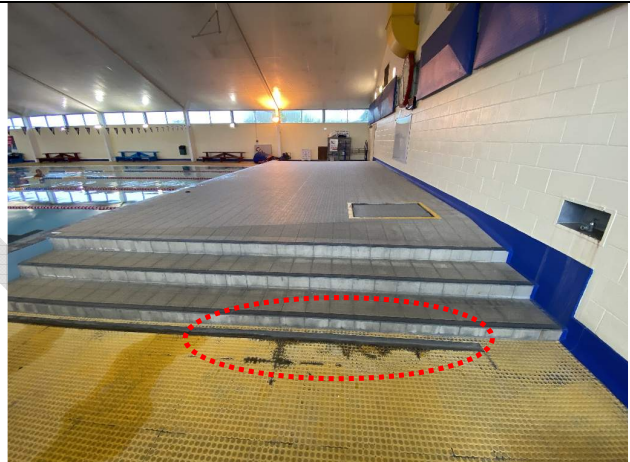
Item	2014 Report	2021 Inspection Findings	
A	POOL HALL INTERIOR		
1	Floor		
	<p><i>The main concourse floor consists of Pirelli type rubber flooring tiles. These are in poor condition. The edges of the tiles are lifting in places, and are unsightly in appearance.</i></p>	<p>Largely unchanged.</p> <ul style="list-style-type: none"> • There are small areas where Pirelli tile edges are uplifted, notably at pool ends. • Pirelli tiles are still in poor, but serviceable condition. • Slip resistant ceramic tiles to pool ends are in a worn but serviceable condition. • Note that there is a hazard in the change of level at the balance tank hatch lid. We recommend that the lid be packed to make the hatch flush with the adjacent tiles. • Open drains to pool edges still as existing, with an exposed aggregate finish.

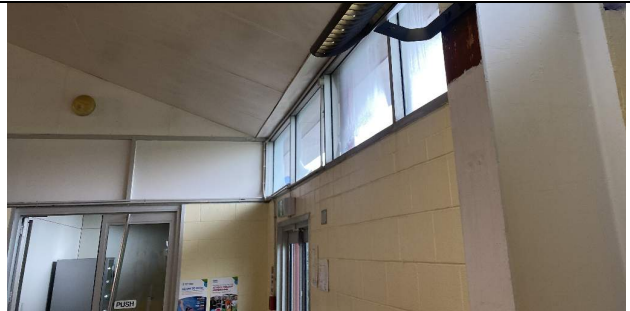
2	Walls		
	<p><i>Concrete block walls were in good condition.</i></p>	<p>Largely unchanged;</p> <ul style="list-style-type: none"> • Paint finishes in good condition, and there is no sign of cracking or wall movement. • As noted in previous reports, there is no insulation to the concrete walls. The walls felt damp in places, due to the cooler outside temperatures and condensation forming on the walls. This is unlikely to be a long term durability issue.

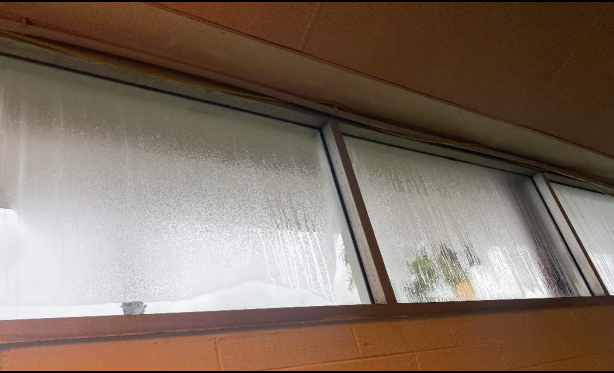
Item	2014 Report	2021 Inspection Findings	
3.	<p>Windows and Doors</p> <p><i>Windows comprise a non-thermally broken, single glazed commercial suite more suited to shop front purposes. As noted previously, they are unsuitable for use in a modern pool facility.</i></p>	<p>Condensation was noted on the inside of windows, due to the cooler exterior conditions and the warm humid indoor conditions. While unsightly, this is not a long term durability issue. Refer general comments below on building envelope and energy efficiency.</p>

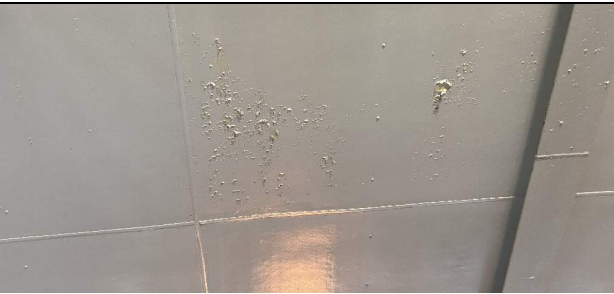
4	<p>Ceilings</p> <p><i>The painted Hardiflex ceiling within the pool hall was in generally good condition. There were no signs of staining as a result of water (leaks and/or condensation) The pool hall was noted as having poor acoustics, and the HVAC plant was particularly noisy. It was noted that the hardiflex sheets were sealed with silicone sealant to the portal frames and that this junction had subsequently been painted over. This has led to unsightly peeling of the paint at this junction. (refer photo above)</i></p>	<p>The Hardiflex ceiling was in generally good condition, with some flaking noted to paint coatings.</p> <p>The silicone sealant to the portal frame has paint peeling as was noted in the previous report. In the absence of an impervious vapour barrier and minimal insulation, the ceiling and how it is sealed to adjacent structure takes on added importance as a first line of defence for chloramine laden air getting into the ceiling cavity. If this pool air is able to enter the ceiling cavity, it can be expected that condensation will form on the underside of the roofing and affect the durability of building fabric within this space.</p> <p>Refer to comments below on the roof and supporting structure.</p>

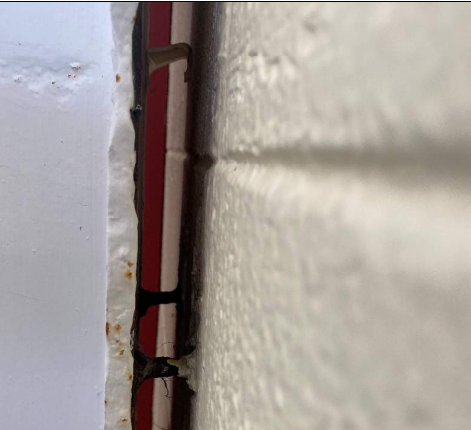
7.	<p>Changerooms</p> <p><i>Change rooms are of simple robust construction with painted concrete block walls, painted fibre cement ceilings in pvc jointers and concrete floor finished with what appears to be an acrylic plaster coating.</i></p> <p><i>There were no signs of physical degradation of a significant nature. However, we did note that plaster floor coatings are failing at gutters near the whb and in the showers. There were a number of locations on the changeroom ceiling where paint was peeling in patches.</i></p>	<p>Unchanged from previous inspection;</p> <ul style="list-style-type: none"> • Ceiling paint finish flaking. • Block walls are in good condition and appear to have been painted recently. • Noted that the space between the column and the block wall (as pictured) is unfilled, and there is degradation noted to the ties between the column and the wall. Refer BECA Comment below.

<p>BECA (Murray Chalmers) Comment;</p> <ul style="list-style-type: none"> • <i>The corrosion to the U-Bolt connections between the columns and change room block walls was identified as an issue in Section 2.2 of the initial April 2015 DSA. It was again highlighted in Notes following the Summary of Findings the August 2021 update as follows:</i> <p><i>Notes:</i></p> <ul style="list-style-type: none"> • <i>The portal leg/masonry wall connection was assessed at 55% being governed by the shear capacity of the U-bolt ties. However, there was one connection that was badly corroded and was assessed at 20%. The score of the portal/masonry wall connection was scaled down from 55% to 40% to compensate for the corroded connection. If this corroded connection is replaced, the score for the portal/masonry wall will be 55%.</i> • <i>The capacity of the U-Bolts is the governing factor limiting the overall score for the Old Lap Pool Building to 40%NBS.</i> • <i>Consequently, remedial work is required and these U-Bolt connections should be upgraded or replaced.</i>

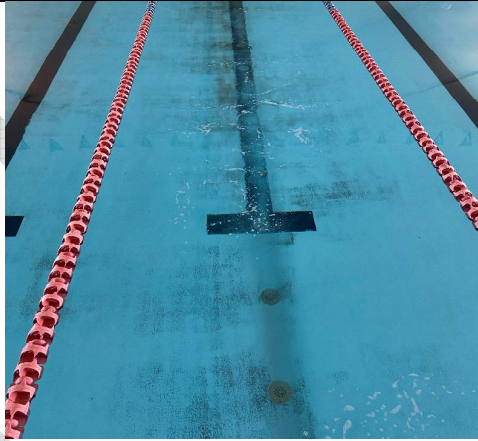
Item	2014 Report	2021 Inspection Findings	
8.	Pool Tank		
	<p>The lanes are approx. 2.15M wide and the pool depth is nominally 1.05M to 1.1M. Pool paint finishes are in worn condition. We understand that the pool was painted approx. 3 years ago, and repainting is required in the next year, along with the replacement of construction joint sealant. A stainless steel nosing has been installed to the long sides of the pool. This nosing is slightly out of level and has little slip resistance. The level discrepancy is not considered a major issue, but equally could be readily corrected by packing the stainless steel channel in order that even flow is experienced into the roll out channels. Tiles to the top of the balance tank, nibs and steps are well worn and in generally unsightly in appearance.</p>	<p>The condition of the pool tank appears to be unchanged from the previous inspection. The previous inspection noted that the pool was to be repainted in 2015.</p> <ul style="list-style-type: none"> Pool paint finishes are significantly worn, and the pool requires repainting. The long term durability of the concrete may be affected if left unpainted. It is not clear whether the stainless steel pool edge level has been corrected, however there was no noticeable level difference. The pool tank appears to be a single large tank, with no movement control joints visible.

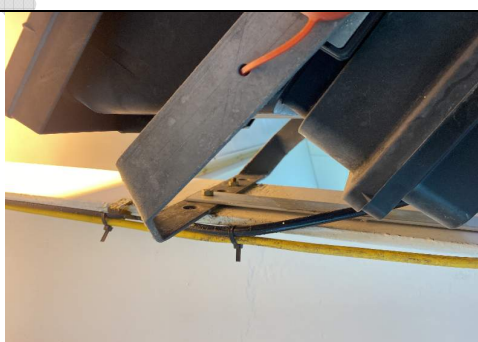
9.	Secondary Fixings (lights, HVAC ducts etc)		
	<p>Not inspected in 2014.</p>	<p>In recent years, there has been an increasing awareness the risk of secondary fixings supporting elements such as lights, speakers and HVAC ducts pose. A limited inspection (where possible) of light fitting fixings was undertaken, and these appeared sound. It is worth noting that as these are mounted on the column face they are not directly above circulation routes and therefore represent a reduced risk to patrons. Access was not possible to HVAC duct supports. We recommend that these supports and fixings be inspected on a 5-7 year basis.</p>

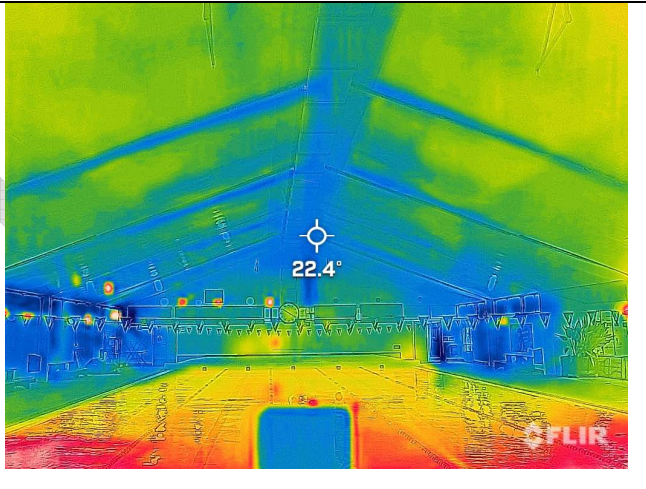
<p>10.</p>	<p>Generally A FLIR infrared camera was used to assess the thermal performance of the building fabric. Refer adjacent photo.</p> <p>The blue (colder) areas indicate where condensation is likely to form first. The entire pool hall has minimal insulation, with only 25mm thick of EPS sheet in the ceiling/roof cavity. The lack of insulation has two consequences;</p> <ul style="list-style-type: none"> • The building fabric is highly inefficient, and is likely to use significantly more energy to heat than a modern building of the same type. • The lack of insulation and an effective vapour barrier promotes condensation during colder outside conditions. This chloramine laden condensation is corrosive and contributes to deterioration of the building fabric. <p>It is worth noting that the new H1/AS2 Energy Efficiency requirements will become mandatory from November 2022. If these requirements were to be applied to the current building, a minimum R value (thermal resistance) of 4.0 for the roof would be required (compared with approximately R0.60 in the current construction). An R value of 2.4 would be required in the walls, compared with approximately 0.18 currently. These increased thermal requirements mean that the only effective method of achieving these values would be the use of insulated panels such as Kingspan high humidity panels.</p>

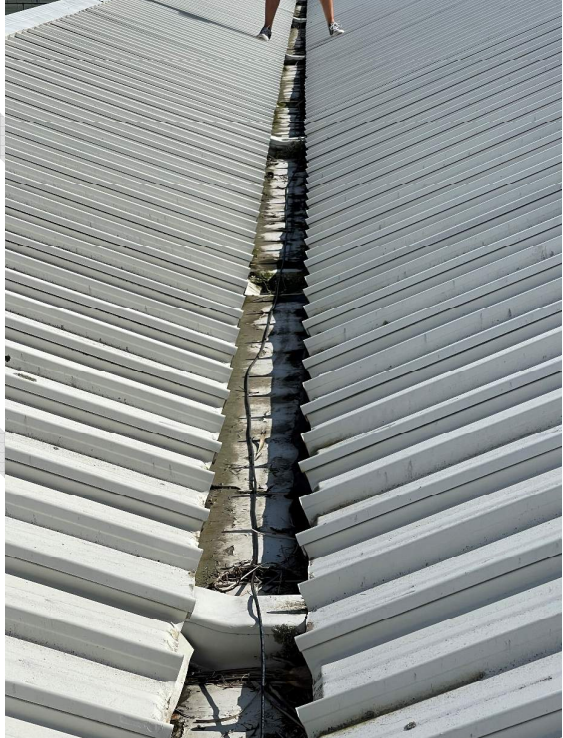
Item	2014 Report	2021 Inspection Findings	
3.	Roof		
	<p><i>The profiled metal roofing and associated roof fixings are in good condition.</i></p> <p><i>The membrane gutters are in poor condition. Sides of the membrane gutter have come loose in places, seriously affecting the integrity of the gutter. There is no sign on the interior of the building of it having leaked to date. New leafguards are required to protect downpipe positions from blocking due to accumulated leaves.</i></p>	<p>The roof was not inspected. The Tufrey Report dated 2nd September 2021 was reviewed. It is not known whether any of the work identified in the Tufrey report has been undertaken.</p> <p>The report identifies a number of issues identified in earlier reports that require attention;</p> <ul style="list-style-type: none"> • Membrane gutters in poor condition, with poor membrane adhesion to substrate and membrane material failure. • Significantly, it is noted that gutter capacity is undersized. • Membranes gutters are full of debris and require cleaning. • It was noted during the visit that there were two locations where leaking had occurred following heavy rain from the previous evening. One of these locations corresponds with the location identified in the Tufrey report. • Some corrosion to roof sheets.

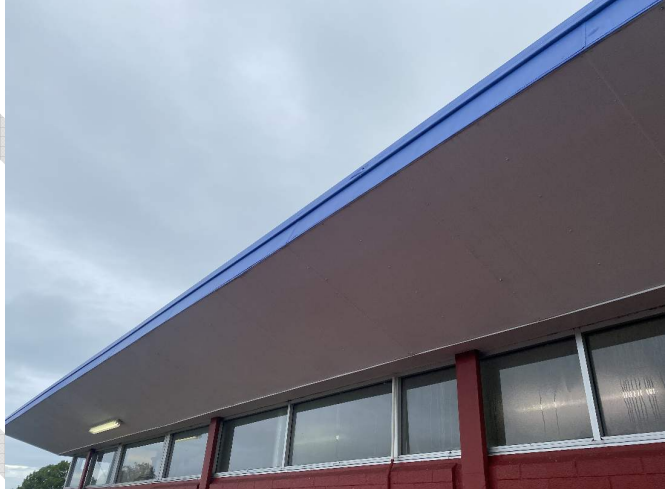
Item	2014 Report	2021 Inspection Findings	
4.	Soffits & Fascia		
	<p><i>A small amount of paint bubbling was noted on the fascia.</i></p>	<p>The dark blue fascia has a number of bubbles in it, as noted previously.</p> <p>Soffit lining has a textured finish and expressed fixings. The soffit is in generally good condition, with a few minor cracks which will not significantly affect the weathertightness or durability of the building.</p>

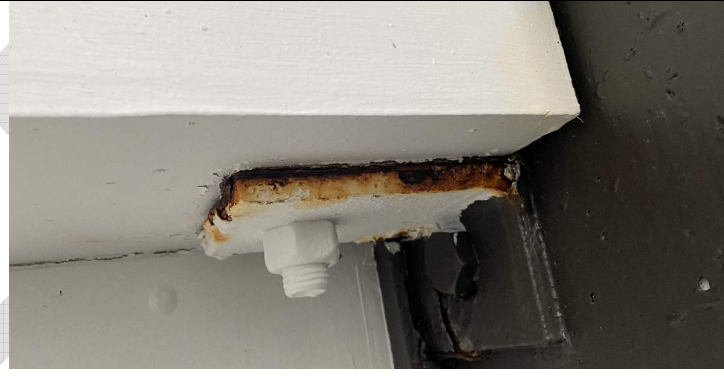
C	IVAN WILSON BUILDING	
1.	<p>Hydroslide Area Bracket</p> <p>Advise from BECA (Murray Chalmers) as follows; <i>Girt Bracket to Hydro Slide</i></p> <ul style="list-style-type: none"> - <i>Similar to the column bases, on the evidence of the photos provided, it does not appear that the extent of corrosion has reached a point where it would result in a significant reduction in the structural capacity of the bracket.</i> - <i>Remedial work is required, which should include the following:</i> <ul style="list-style-type: none"> i. <i>Remove loose rust to base plates and hold down bolts back to bright metal or original galvanised coating if present.</i> ii. <i>Treat brackets and bolts with rust neutralizer, prime with zinc rich paint, and paint repairs to match existing. Replace bolts if easier option.</i> iii. <i>If severe corrosion is found during the remedial work, indicating a substantial loss in steel area of any component, Beca should be advised.</i>

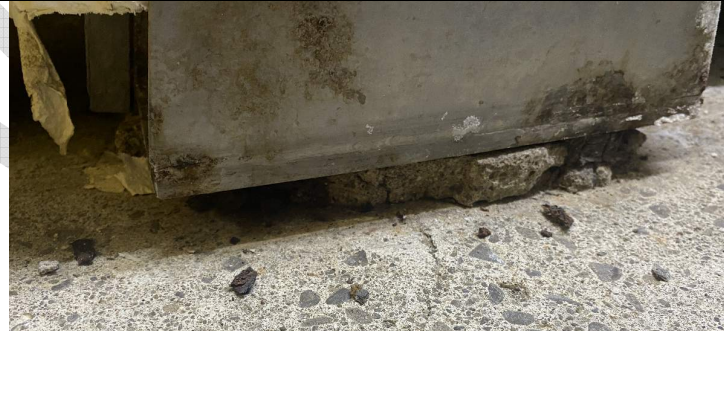
2.	<p>Plant Room Column Base</p> <p>Advise from BECA (Murray Chalmers) as follows; <i>From the photos, it would appear similar remedial work to that outlined above for the Old Lap Pool is required.</i></p> <ul style="list-style-type: none"> i. <i>Breakout and remove mortar packing under base plates back to sound mortar. Provide temporary shims to support columns if required.</i> ii. <i>Remove loose rust to base plates and hold down bolts back to bright metal or original galvanised coating if present.</i> iii. <i>Treat base plates and hold down bolts with rust neutralizer, prime with zinc rich paint, and paint repairs to match existing.</i> iv. <i>Repack mortar beneath base plates.</i> v. <i>If severe corrosion is found during the remedial work, indicating a substantial loss in steel area of any component, Beca should be advised.</i>
