NAPIER WASTEWATER TREATMENT PLANT

Performance Evaluation

NAPIER
CITY COUNCIL
Te Kaunihera o Ahuriri

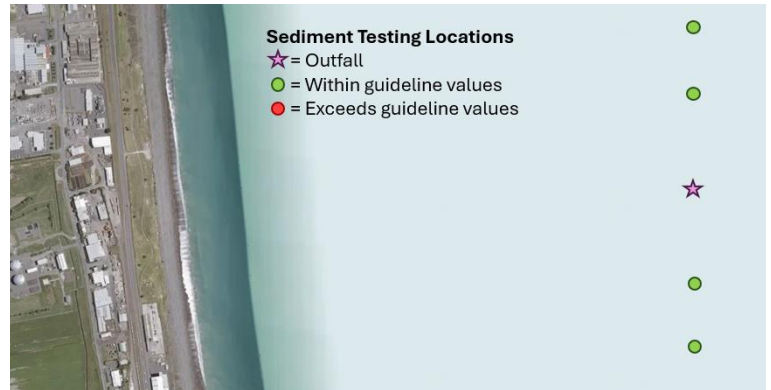
Figure 8: Sediment Testing

Twice a year seabed sediment samples are collected 300 m and 500 m north and south of the outfall diffuser. The samples are analysed for arsenic, cadmium, chromium, copper, mercury, nickel, lead, selenium and zinc. As metals accumulate in sediment, this provides a good measure of the effect of the discharge over time. The results are summarised in Figure 8. All results were within the guideline values for sediment quality (ANZECC & ARMCANZ, 2000).
