NAPIER
CITY COUNCIL
Te Kaunihera o Ahuriri

**AQUATIC
CENTRE**

CAPITAL PROGRAMME

PRELIMINARY REVIEW FINDINGS

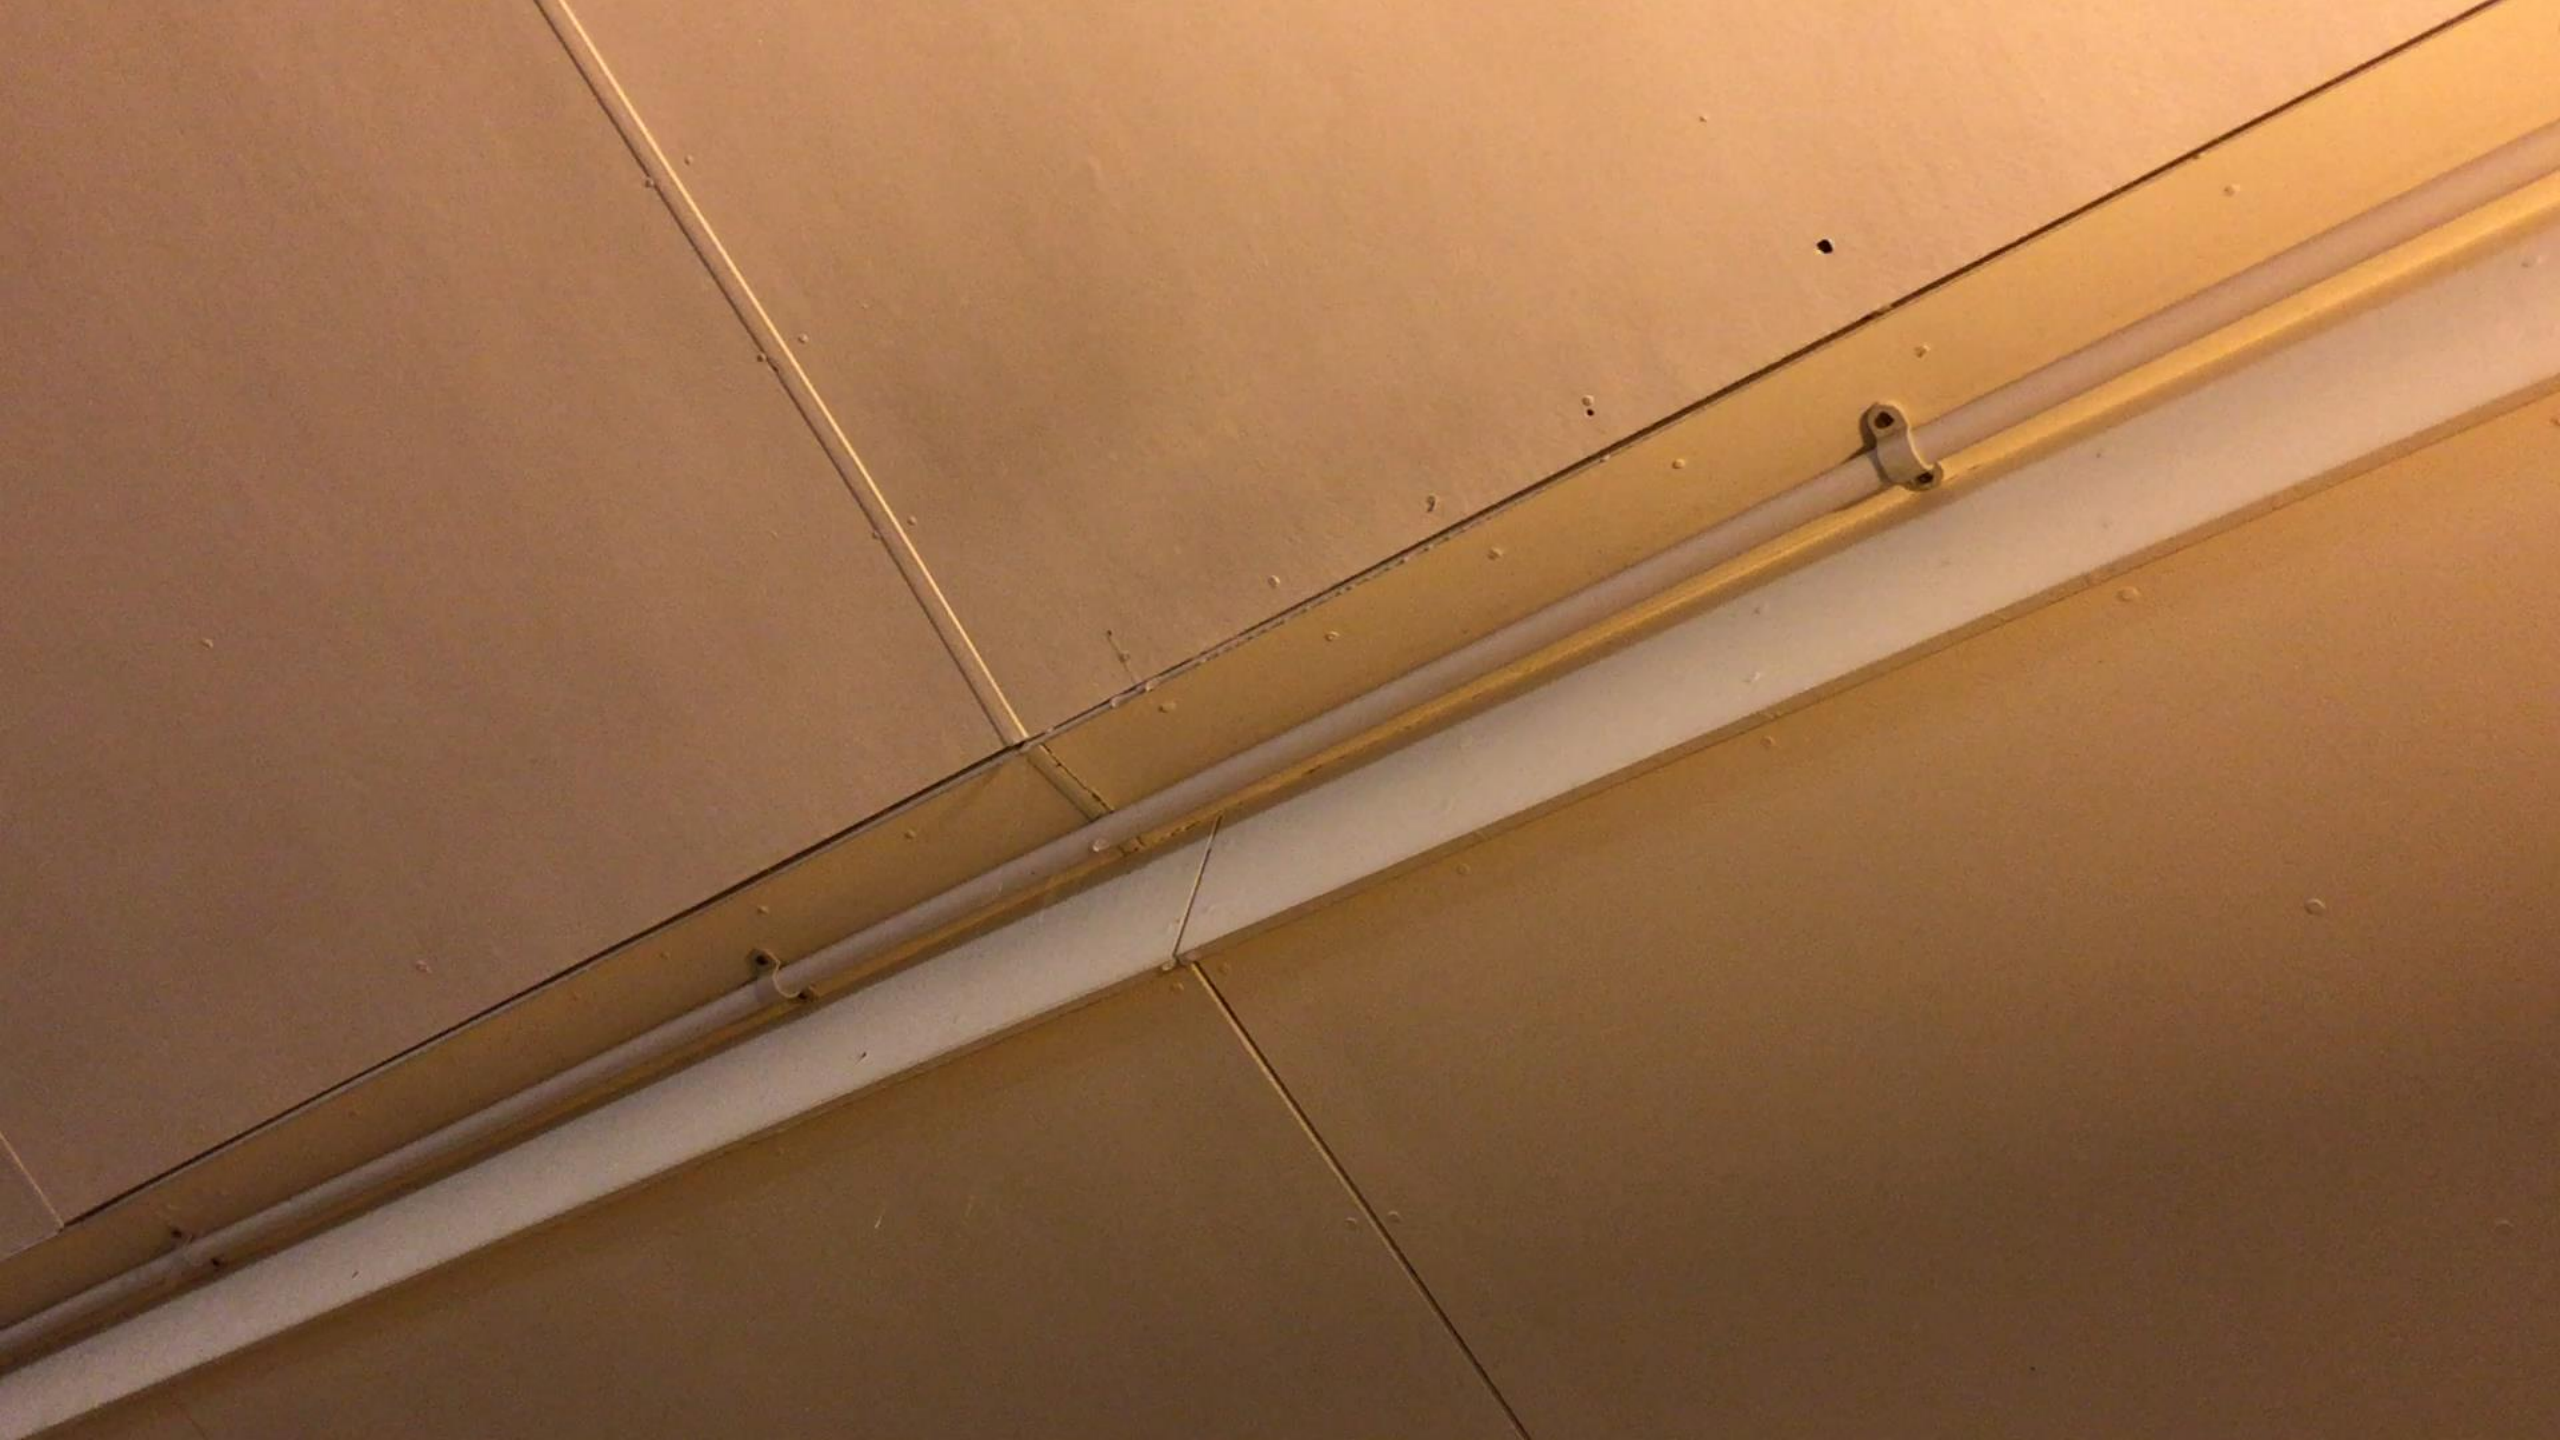
ROOFASSESSMENT

- Inspection found numerous issues from failed membranes, missing or incorrect flashings, incorrect or failed fastenings, poor standards of workmanship with original install or subsequent repairs, undersized gutters, areas of corrosion, gutter failures and issues with debris in gutters and catchments
- Scope of repairs
 - Scaffolding and shrink wrap of building
 - Remove asbestos soffits and fascia
 - Remove existing roofing
 - Carpentry to re-pitch roof
 - Install new Coorsteel roofing

1. Remediating roof

Continuing to have water ingress into facility at numerous points, damaging framing, cladding and equipment

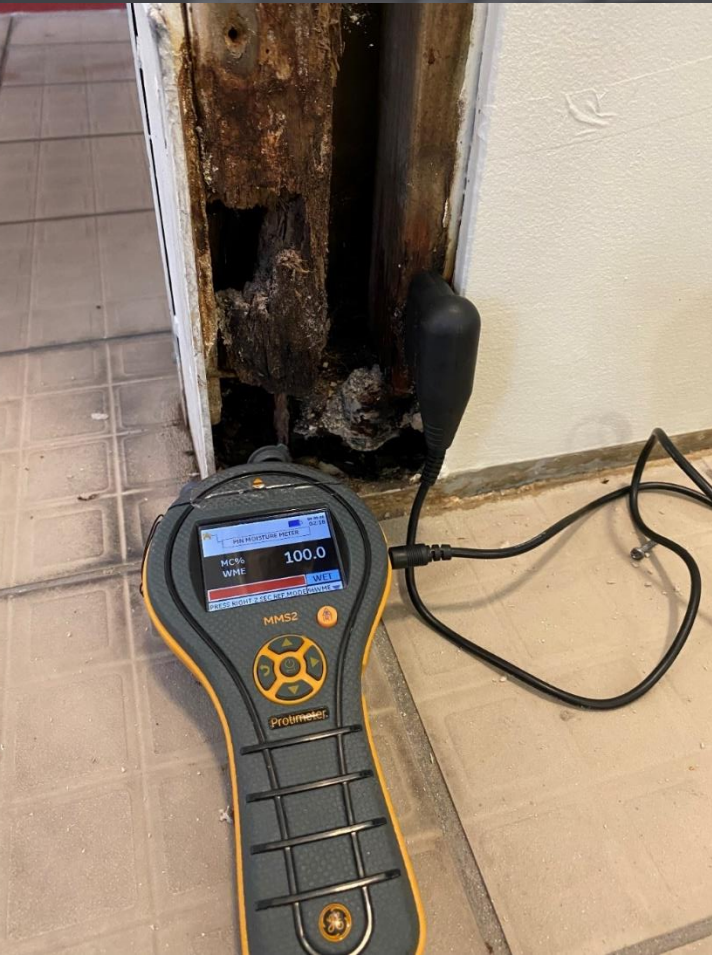
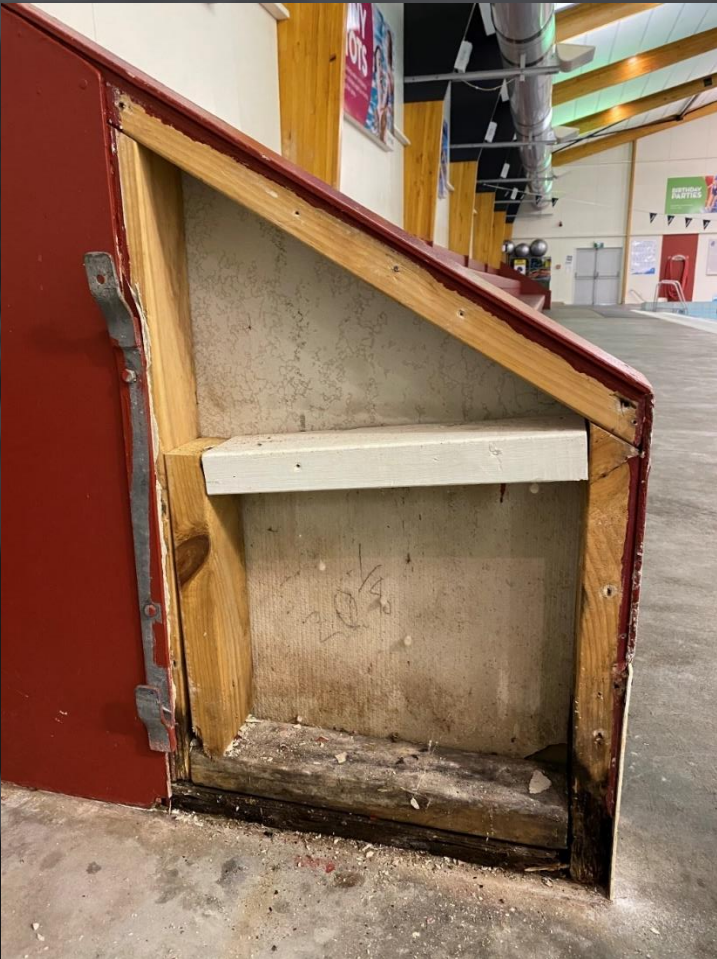
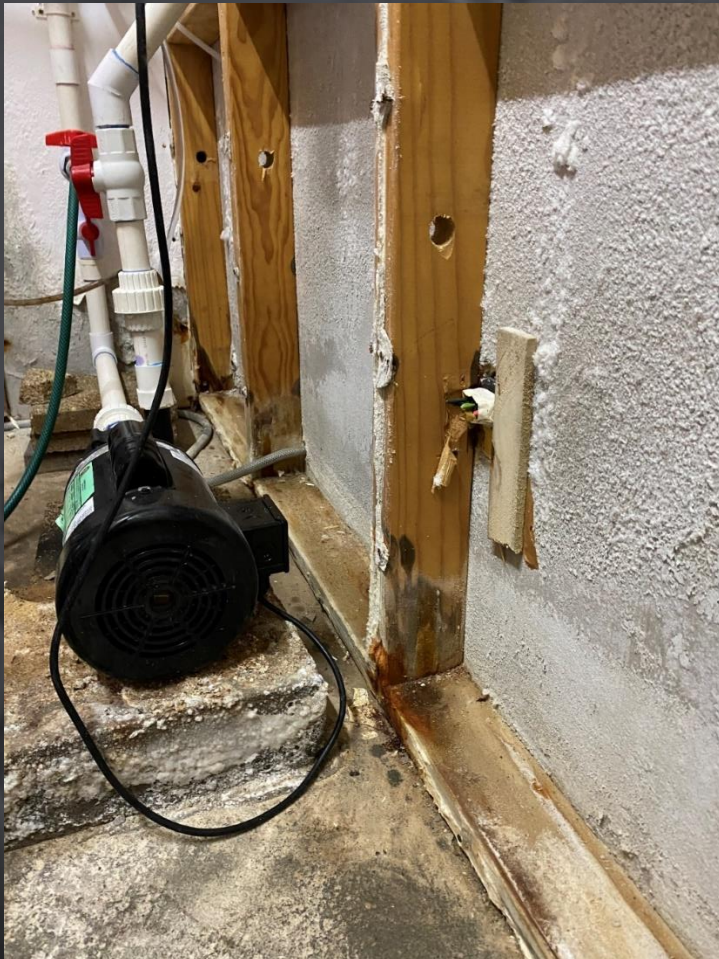
INTERNAL WALLS

Internal cladding and framing is seriously degraded due to 20 years of water ingress during cleaning

- Moisture in the bottom plates has eroded fixings in places, resulting in compromised structural integrity

- Site Prep/Demolition/Protection of Services etc
- Concrete Nibs
- Construction of New Walls/Linings
- External Aluminium Joinery
- Internal Doors
- Strip Drain to Exterior Wall facing Splash Pad - 300mm wide

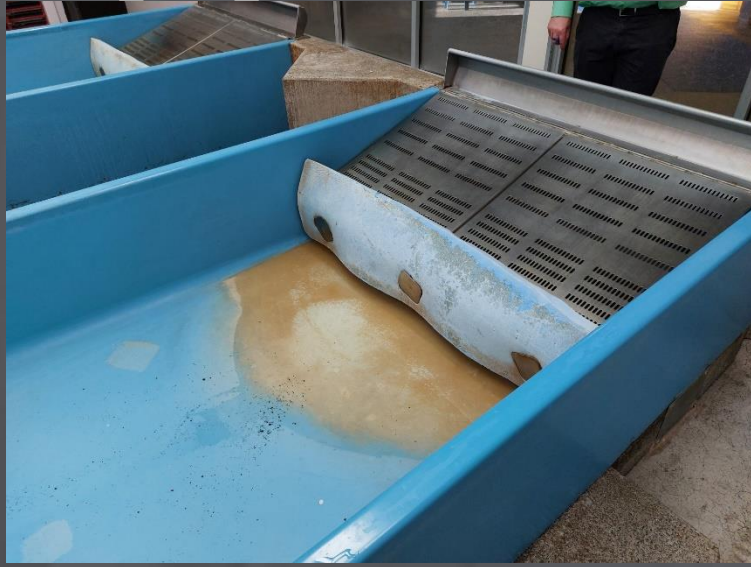
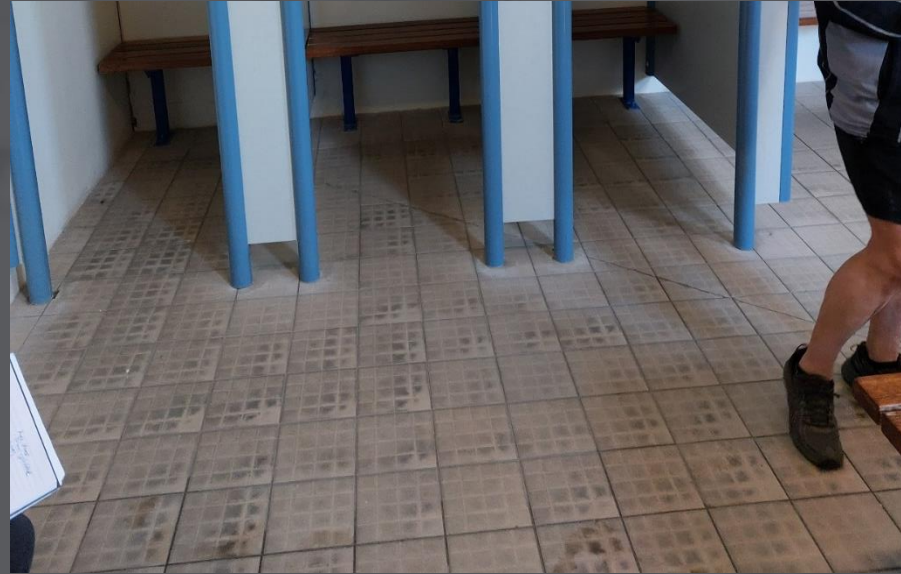
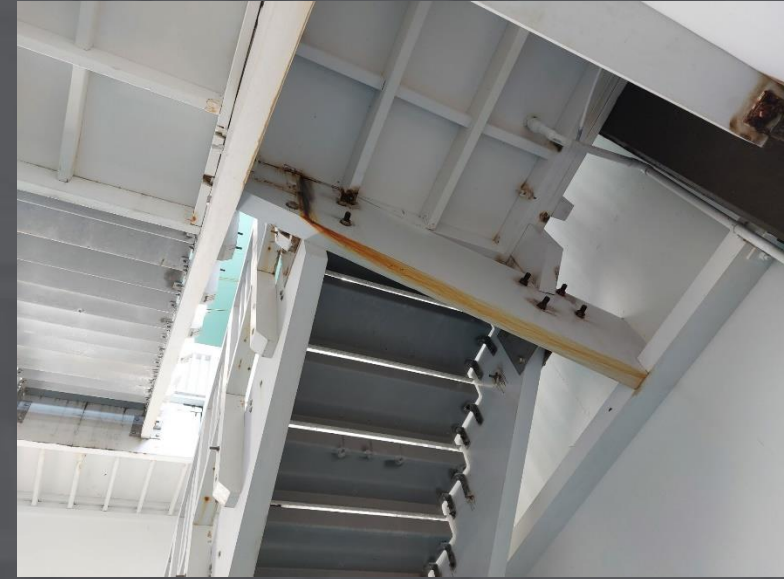
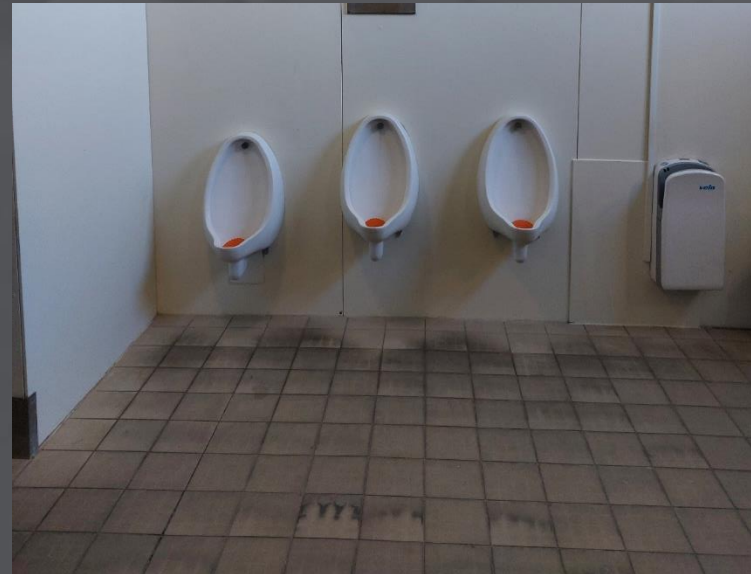
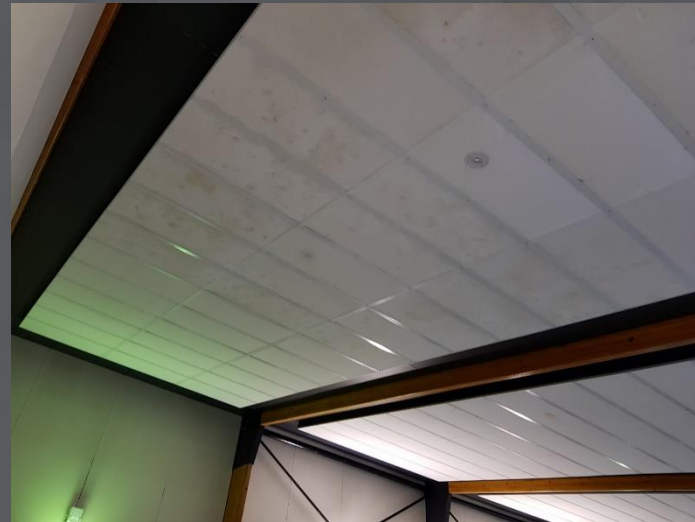
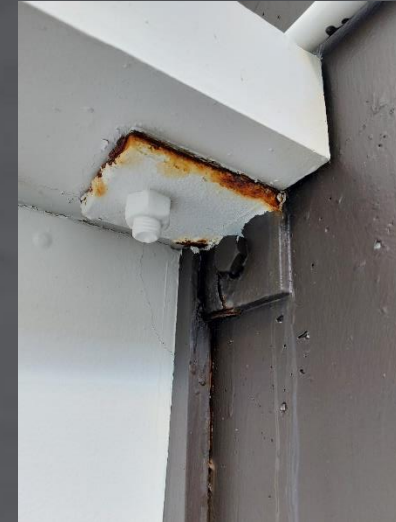
UPDATE VANWILSON

- 23 year old facility in need of decent upgrade
- Design issues impacting operations and asset condition

- Ceiling panels failing (again)
- Condition of changing rooms and cladding continuing to impact customer satisfaction and lose customers

- Refurbishment of male, female and family changing rooms – including flooring
- Incorporation of accessibility improvements from Barrier Free assessment
- Interior painting
- Acoustic ceiling panel replacement

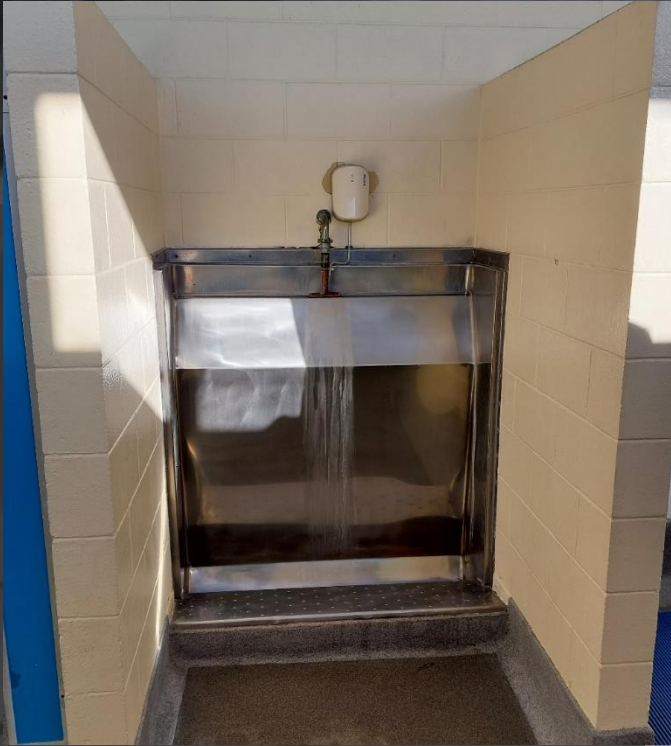
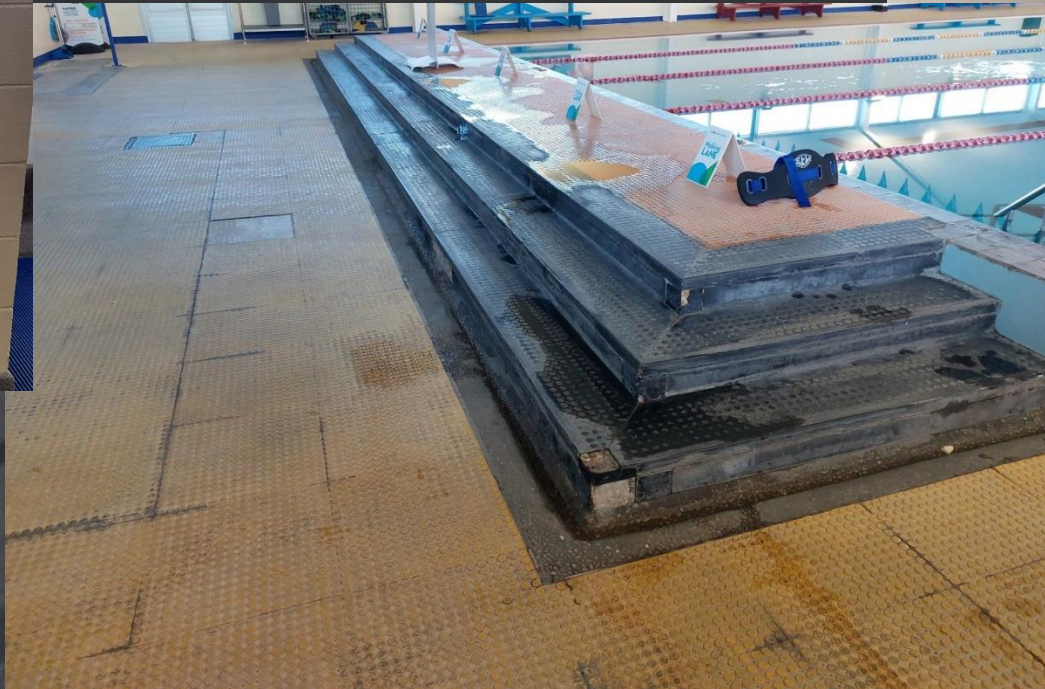
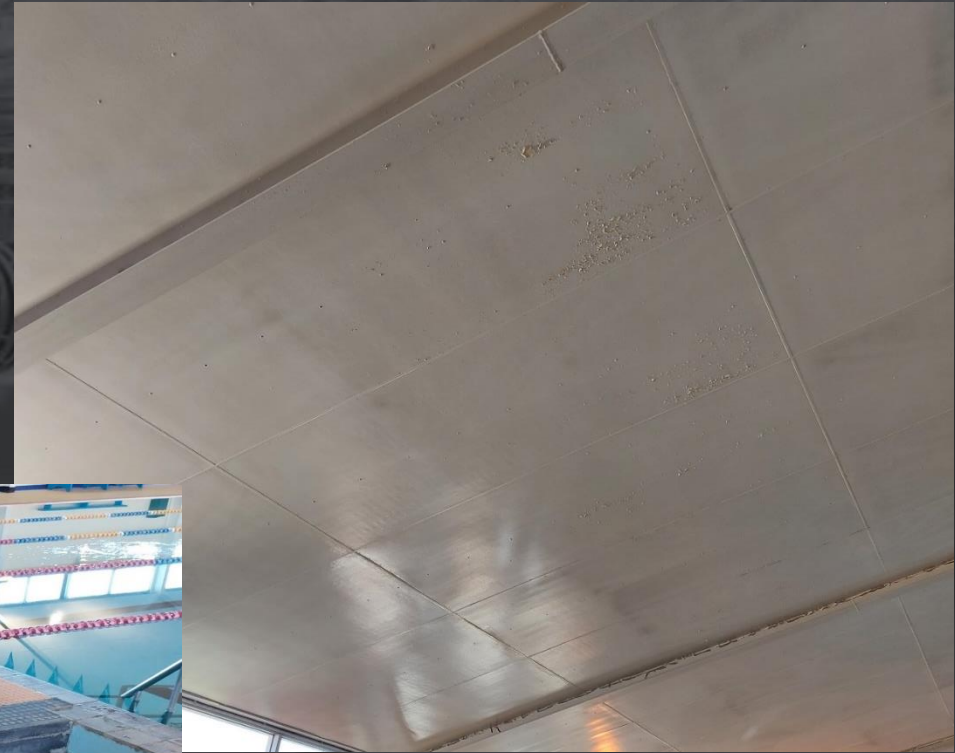
UPDATE OLD POOL

- Pool at end of life and in very poor condition
- Safety concerns with asbestos cladding
- Terrible acoustics making teaching environment difficult and impacting

- Asbestos condition deteriorating causing risk to customers and team
- Poor condition of facility continuing to impact customer experience and visitation

- Refurbishment of male and female changing rooms
- Asbestos ceiling replacement
- Interior painting
- Flooring replacement – pool concourse
- Acoustic improvements

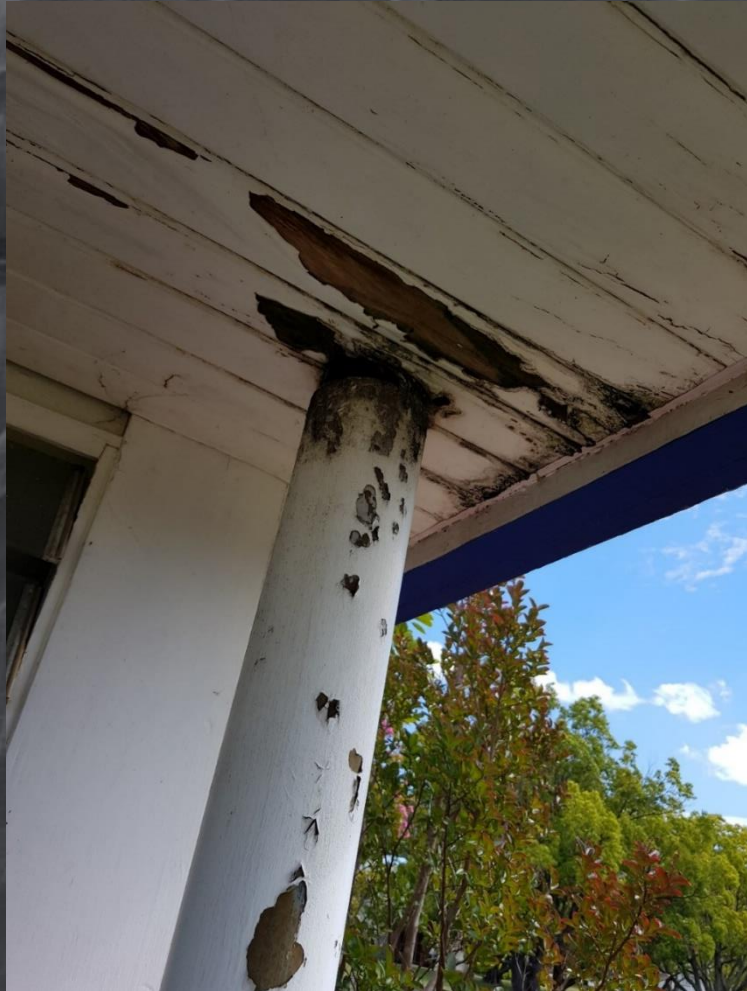
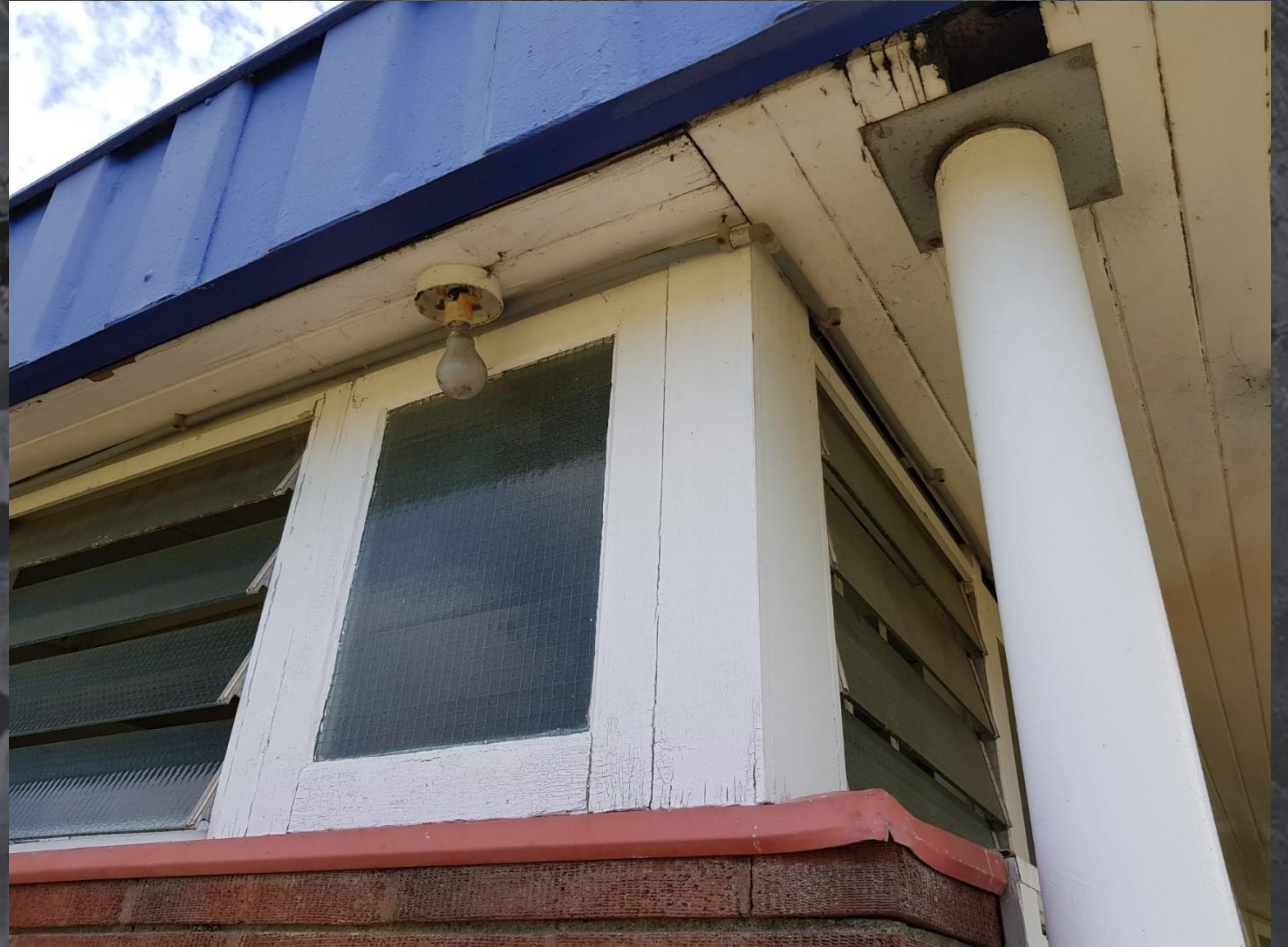
UPDATE ALLANS POOL

- Key facility for learn to swim for smaller kids
- Condition a barrier for potential customers
- Enable revenue growth

- Declining Swim School numbers
- Deteriorating facility

- Ceiling and wall lining replacement
- Male, female and staff changing room refurbishment
