HASTINGS OUTFALL PIPE INSPECTION

PREPARED FOR HASTINGS DISTRICT COUNCIL

20/09/2019

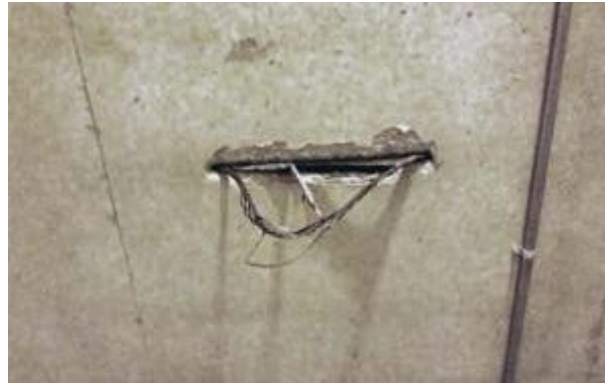
Figure 4-1: Eruption of PT Tendons caused by Corrosion Failure (Vector Corrosion Technologies, 2019)

It is understood that the 15 mm high tensile steel strands were coated with polyethylene which should protect the strand from corrosion. Should sea water reach the post tensioned wires weakening the strands until failure, the release in tension may cause sudden forces within the ducts which may burst through as seen in Figure 4-1 leading to further seawater infiltration.

The broken strand can then no longer resist axial forces along the pipeline inducing increased stresses in the remaining strands. The joints however were designed such that the final load after creep of articulation bearings and strands was to be 180 tons which was equivalent to 47% of the ultimate stress of the strand. The anticipated pulling load was 75 tons with a max limited to 150 tons such that a generous margin of safety was allowed for bending during burial (Thomson). Hence, depending on the wave loading causing movement in the pipeline, there may be significant redundancy in these tendons should they only be restraining pressure forces, which can be explored in the next phase of the study.

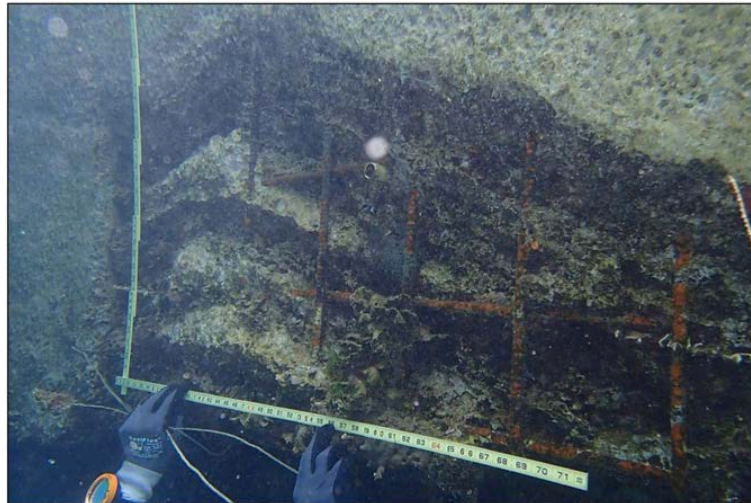
Figure 4-3: Example of underwater spalling (Republic of the Marshall Islands Ports Authority, 2015)

Corrosion of the reinforcing wires could cause spalling, as in Figure 4-3, which will cause pieces of concrete to break off, further reducing the susceptibility to corrosion of the surround wires as well as reducing the strength of the pipeline as the wires no longer provide tension resistance. This could also cause leaks in the pipeline if a large portion of concrete breaks out. This would be visible early as rust forms on the surface of the concrete or bulging occurs.

PHOTOGRAPH 134: Open spill with exposed rebar on Uliga Dock pile cap from Sta. 07+46 to Sta. 07+51
